The effect of transient overloads on the stress-rupture of glass fibre reinforced polymers

submitted by J.D.Rawles
for the degree of Ph.D.
of the University of Bath.

1990

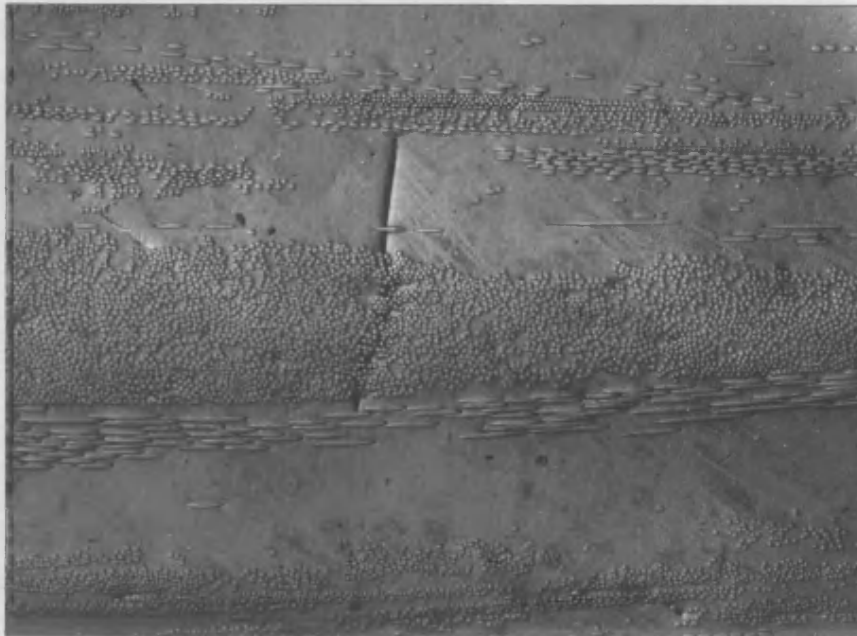
FIGURE 8.6

Optical micrograph showing resin cracking originating from a transverse roving bundle after one 60% UTUS overload cycle. Magnification: 50.

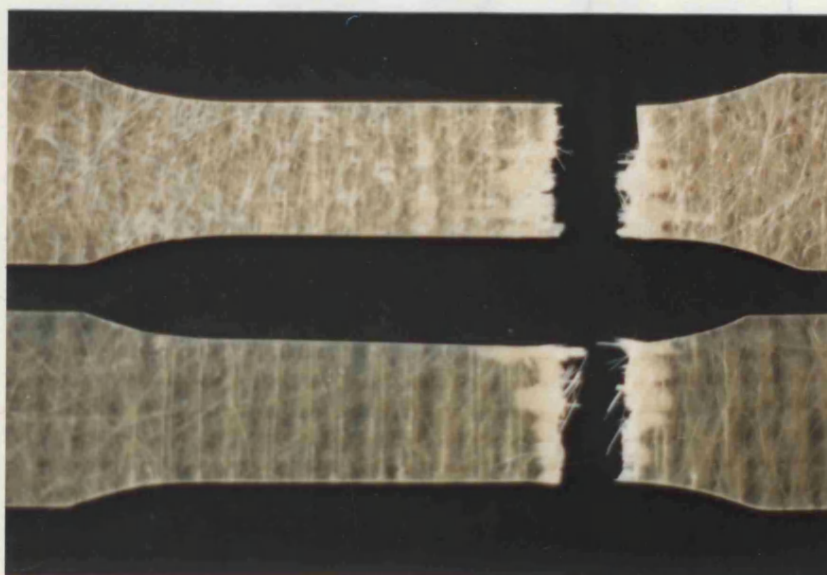
FIGURE 8.17

Overloaded Vinyl ester coupons.
Stress-rupture failures at the 40% UTUS load level.

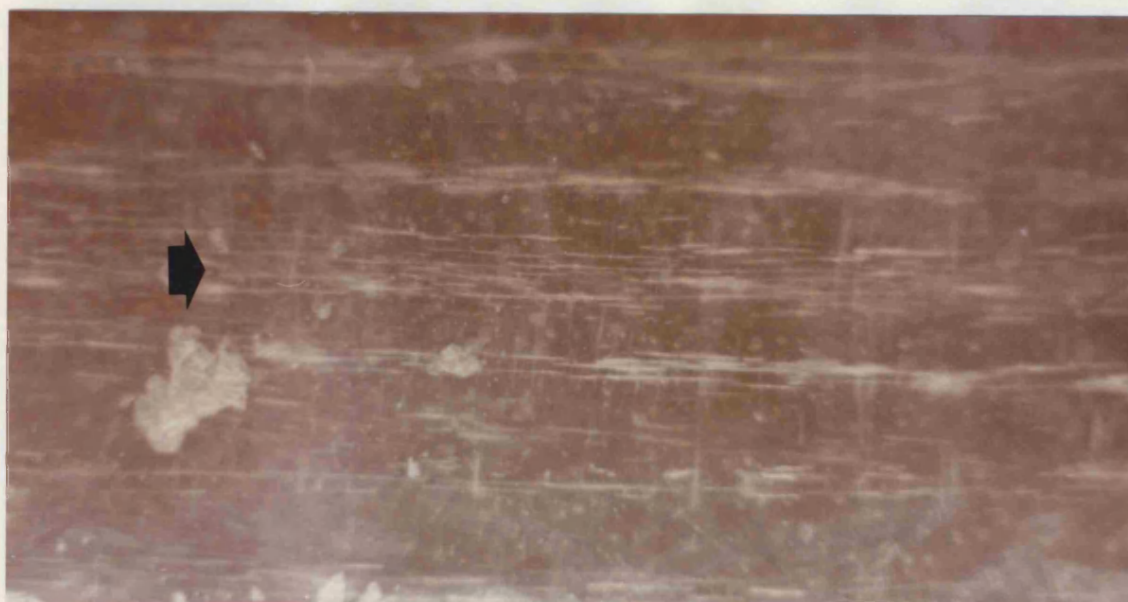
FIGURE 11.4

Band of axial debonding/resin cracking.

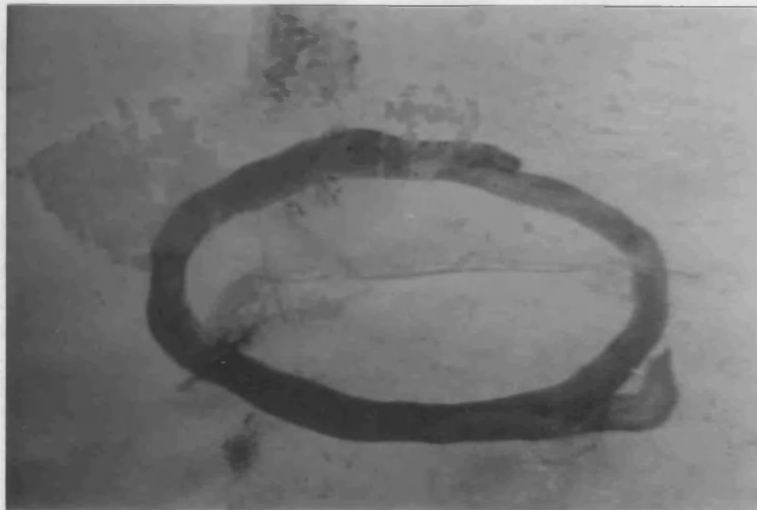
FIGURE 11.10

Point of leakage in a failed virgin pipe.
